Locating Power Line Noise Using TV Waveforms

The author describes a valuable technique for locating and tracking power-line noise.

Marv Loftness, KB7KK

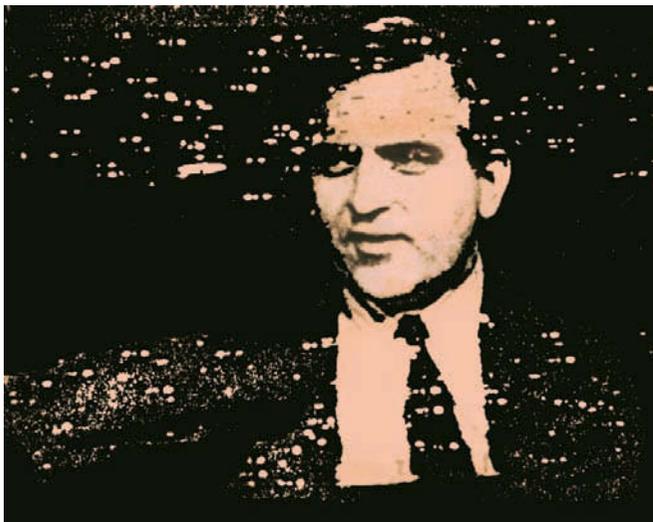
Figure 5—A typical electrical noise pattern as seen on a TV image.

5) A group in a pair usually has a somewhat rectangular shape but, occasionally you will see groups with rounded or triangular shaped characteristics. If the groups in the pair consist of sharp spikes, however, and if the A group is different in some degree from the B group and if a noise pattern drifts across a TV video pattern, *you know you are looking at electrical noise*. The noise resulting from pattern (1) of Figure 4 will cause a TV video interference picture very much like that seen in Figure 5.
